Asbestos Inspection Report for Newington Town Hall 131 Cedar Street Newington, CT 06108

> Crawl Spaces and Pipe Chase Tunnels

Prepared for Town of Newington 131 Cedar Street Newington, CT 06108

EnviroMed Project # IH-15-026

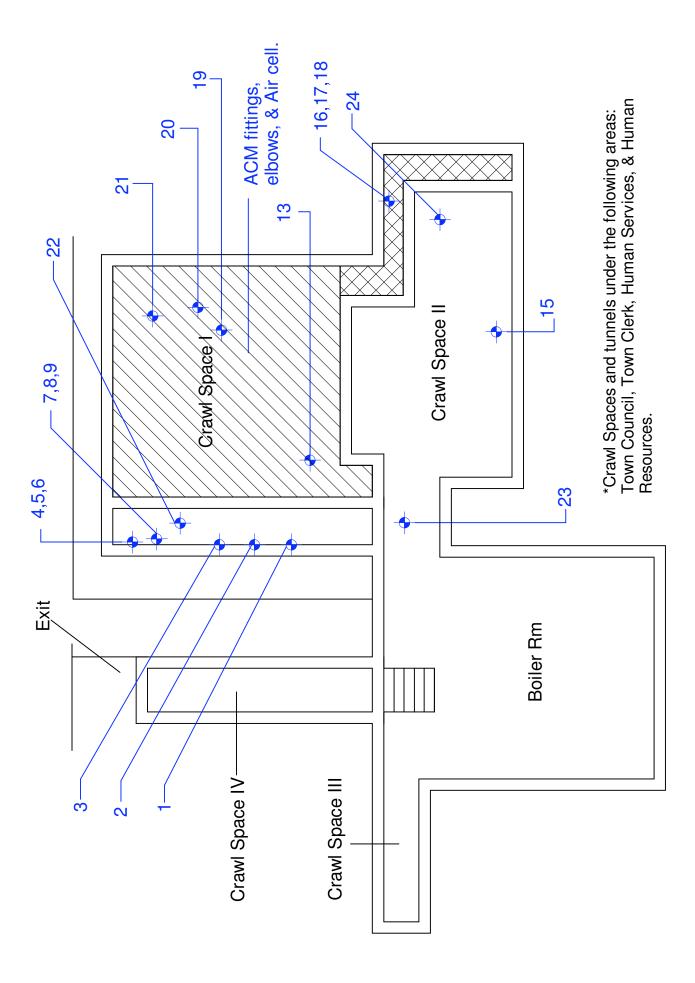
Newington Town Hall - Crawl Spaces & Tunnels Asbestos Sample Location Diagram February 2015 = Asbestos Sample Location

Pipe Chase along Crawl Space II & Lower Tunnel area—Approximately 1000 Linear Feet
